# Manhole Inspection Summary

Manhole # S31I11005MH

Insp Date: **3/20/07 2:18 PM**

**Location** Address: **31 WARRENTON RD**

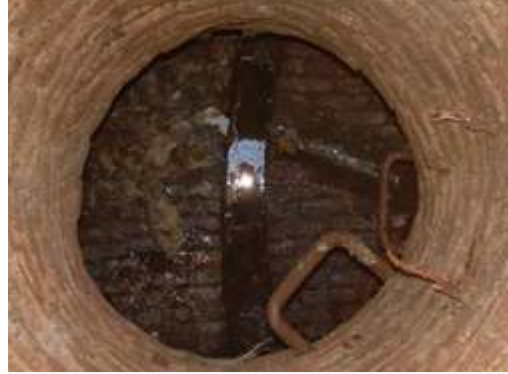
Top View

Corroded and missing steps. Evidence of surcharge - Bench debris. Channel debris.

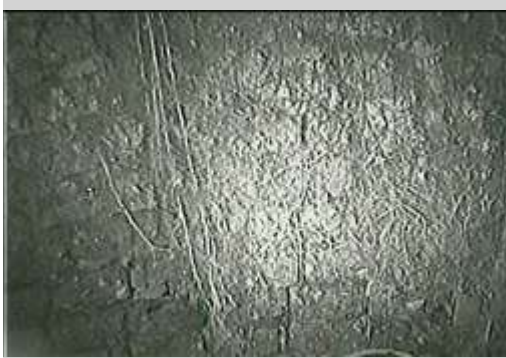
Defect

Barrel deterioration, root intrusion and infiltration.

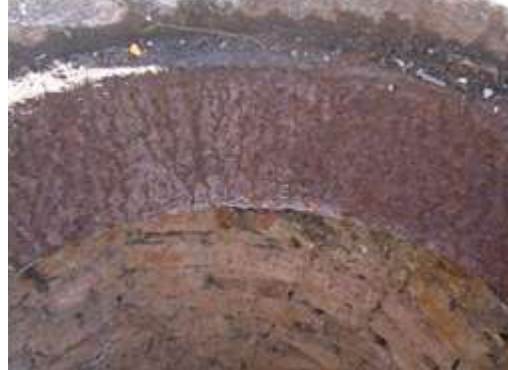
Defect

Adjustment and Corbel deterioration, root intrusion and infiltration.

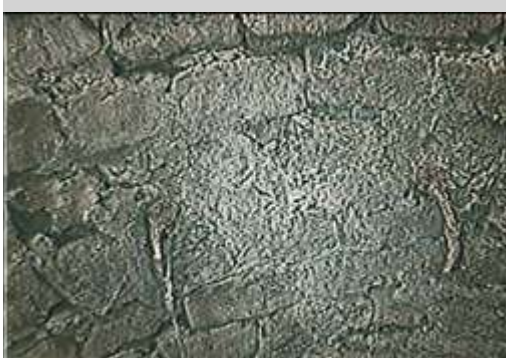
Defect

Corbel deterioration and infiltration.

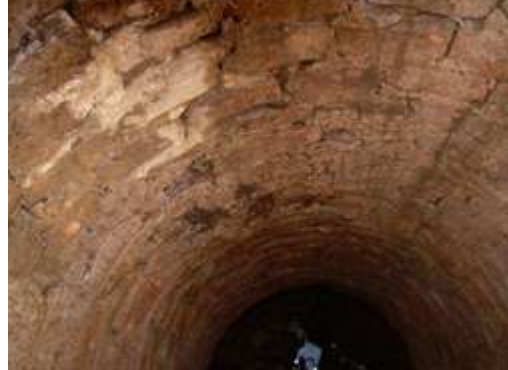
Defect

Adjustment and Corbel deterioration, root intrusion and infiltration. Barrel infiltration.

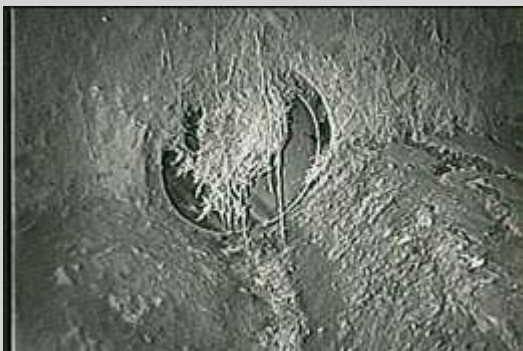
### 6 in. Circular Gravity Sewer Pipe In @ 3 O'Clock

Infiltration: **Evidence** Pipe Seal Cond: **Roots**
